HISTORIC PRESERVATION CERTIFICATION
APPLICATION—PART 1

1. Name of property: 1718 West Lexington StreetAddress of property: 1718 West Lexington StreetCity Baltimore County _____ State Maryland Zip Code 21223Name of historic district in which property is located: Franklin Square Historic District

CONTINUATION SHEET FOR:
1718 West Lexington St., Baltimore, Maryland 21223
FRANKLIN SQUARE HISTORIC DISTRICT
HISTORIC PRESERVATION CERTIFICATION APPLICATION - PART 1

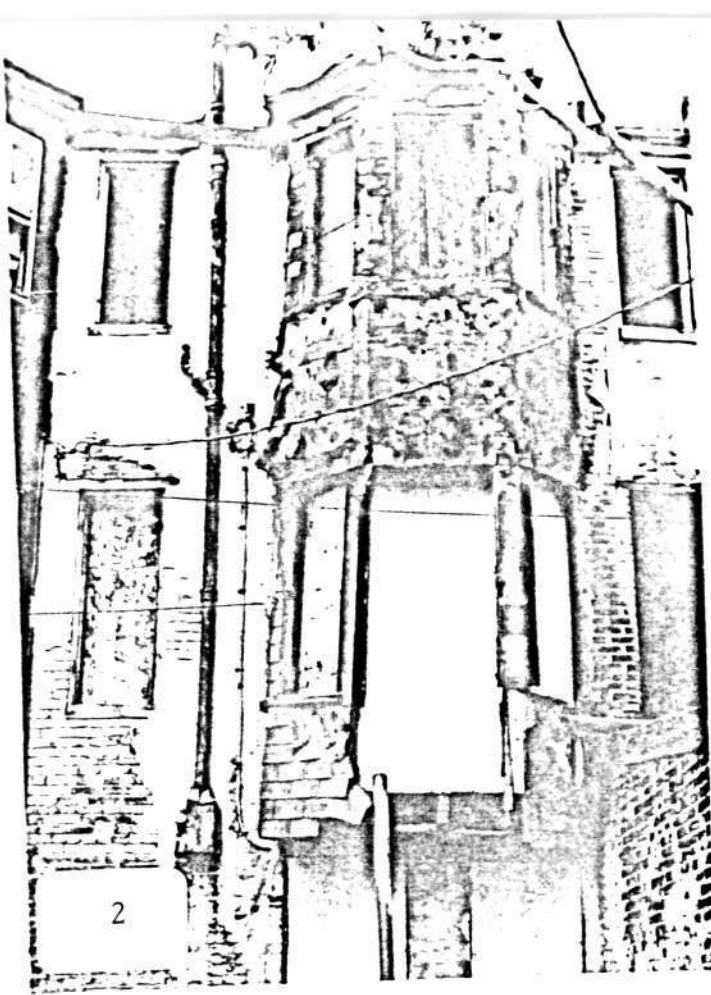
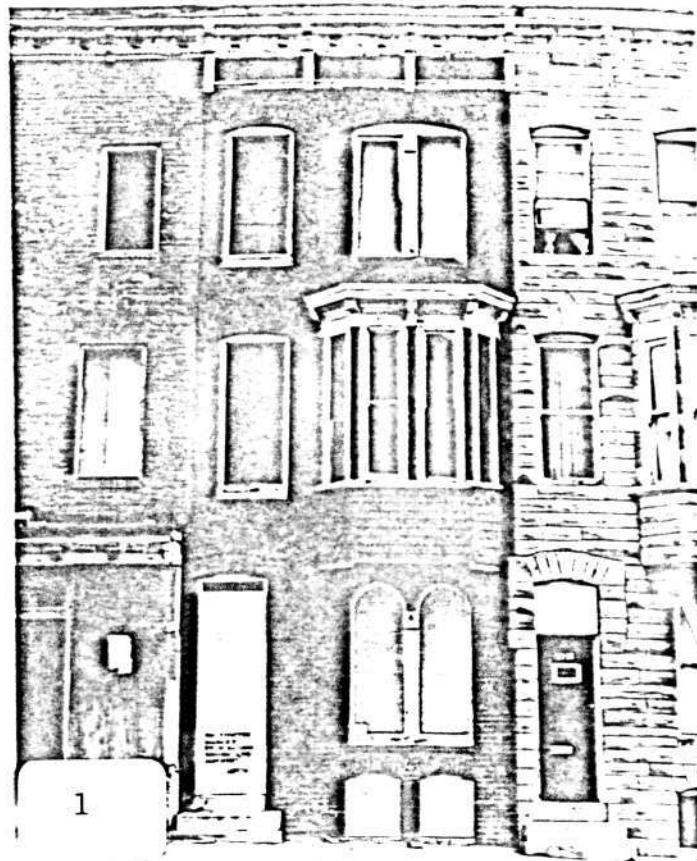
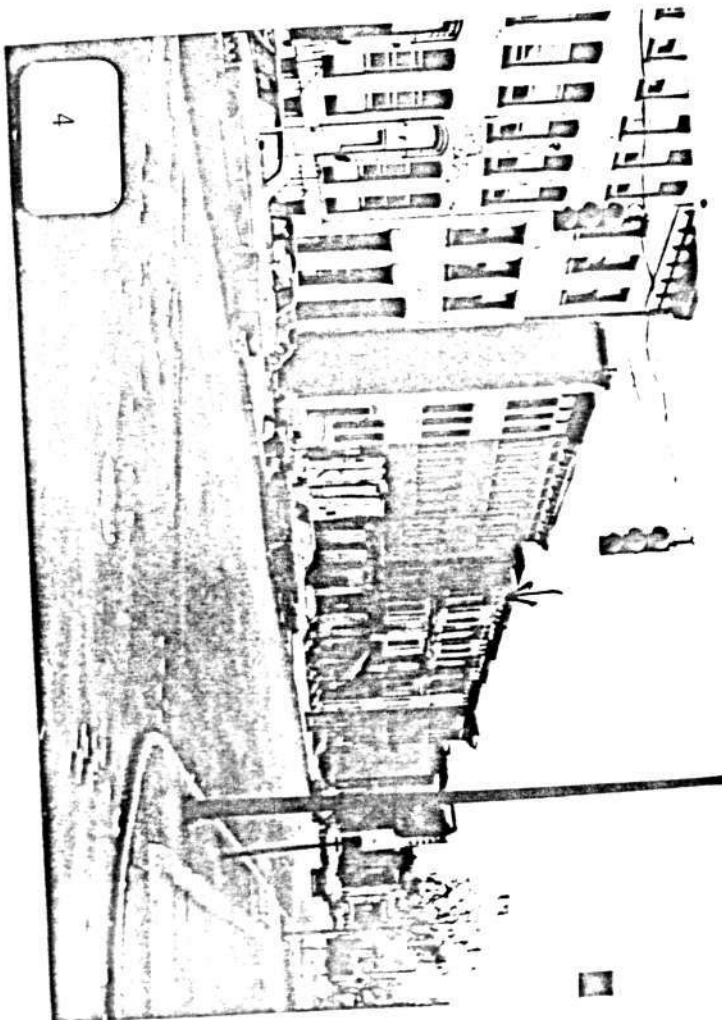
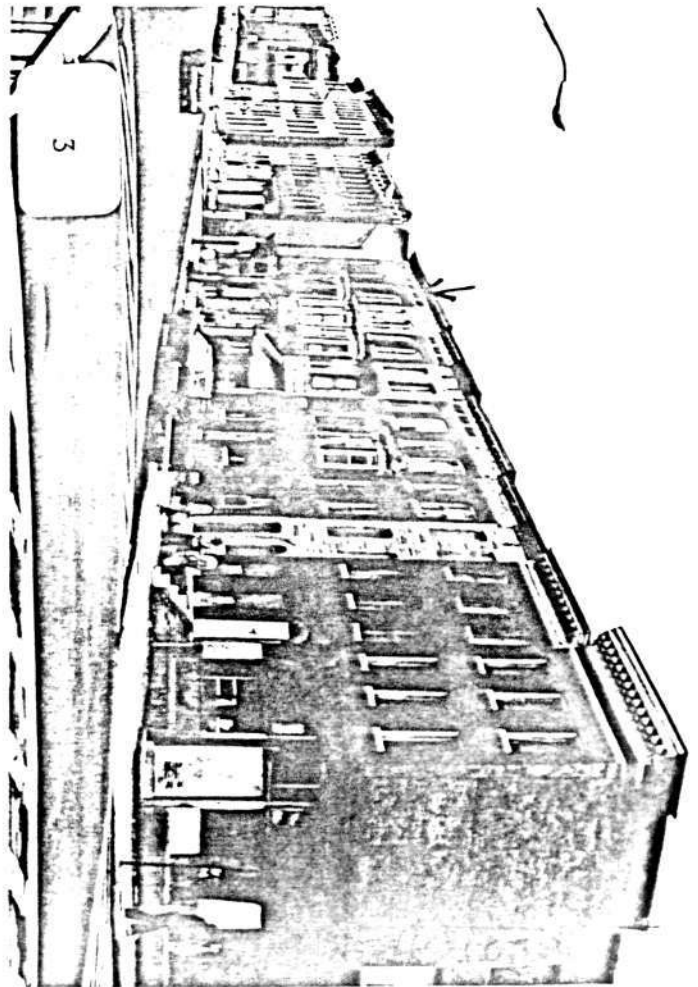
See photographs 1,2,3, and 4.

This house is a narrow, brick rowhouse with marble steps in front, arched windows on the first floor front and a bay window on the second floor front and on the second and third floors rear. The house has considerable (con't)

2. fire damage in the rear section of the house. All three floors are full size with three rooms on each floor. There are three fireplaces in the house with no mantels. About half of the original door are still in the house, the floors in the front section appear to be in relatively good shape, some moldings and casings remain, the newel posts and banisters are still intact, and the window casing on the front, first floor double arched windows remain. There are no bathrooms or kitchen. The front bedroom on the second floor has a small room within it that may have been used as a closet or nursery. There is a skylight in the third floor hall.

3. the first floor front and marble steps. The bay window and the top of the house have fine trim and cornice work. All three floors are the same size. The house has double bay windows on the second and third floor rear although they are unstable at present due to the fire. The casing around the double arched windows in the front is in good shape as are the floors in the front rooms on all three floors. The original banisters and railings remain in the house although the mantles have been removed from the three fireplaces (one on each floor). The house has an unusual small room with a window looking on the stairway from the first to second floor in the front room which may have been used as a nursery or closet area. A skylight remains in the third floor hall. Further, jack arches highlight the windows and door on the front of the house.
